TITLE OF THESIS: A Technological History of Municipally Owned Public
Transportation in Edmonton, 1893-1981

DEGREE FOR WHICH THESIS WAS PRESENTED: Master of Education

YEAR THIS DEGREE GRANTED: 1985

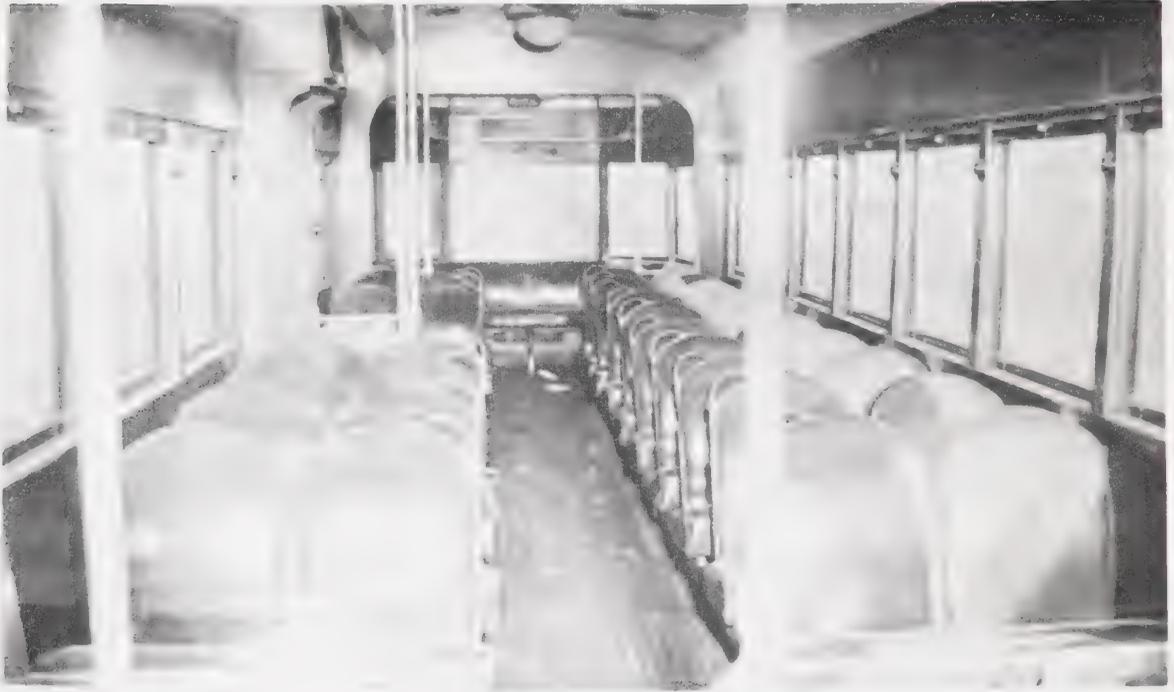
Plate 32. (Author's Collection) Interior of Streetcar Number 84

maple strips were then nailed longitudinally along the aisle areas. On either side of the strips the builder nailed 5/8 inch (16 mm) thick maple boards. These boards were aligned longitudinally. When complete, the flooring was painted with a light stone grey floor paint. The use of maple (a hard wood) for the floor meant that the floor boards would not wear as quickly as the floors in the older streetcars which were laid with pine boards (a soft wood). The flooring extended evenly from one end of the interior to the other. (See Plate 32)

The interior signaling system consisted of a buzzer that operated on trolley voltage that was reduced by a resistor grid. Twenty-five push button switches, connected in parallel, enabled the passengers to operate the buzzer. The switches were mounted on the side posts along the interior as well as on the bulkheads. (See Plate 32)
